ASC-TR-2010-5002

THREATS TO AIRCRAFT STRUCTURAL SAFETY, INCLUDING A COMPENDIUM OF SELECTED STRUCTURAL ACCIDENTS / INCIDENTS

**Engineering Directorate (ASC/EN)
Aeronautical Systems Center**

**MARCH 2010
Final Report**

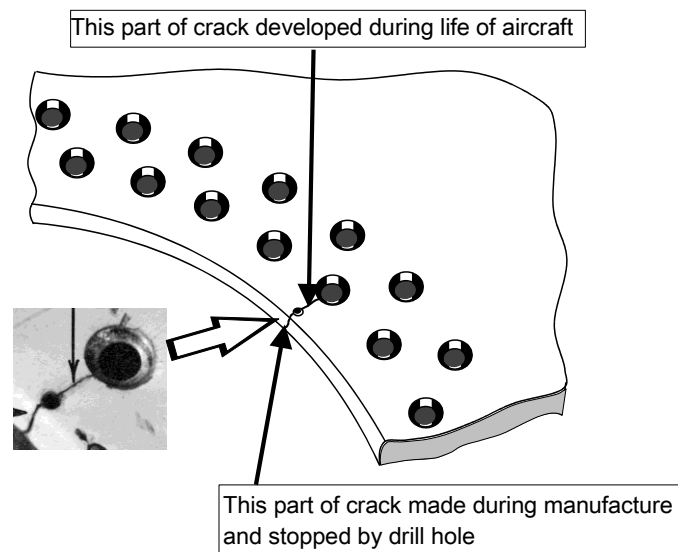
During the reconstruction of G-ALYP, a pre-existing manufacturing crack or tear was found at the edge of the ADF window cut-out (See Figure A4). This crack had been stop-drilled, which was the accepted repair practice at that time. Several other locations in this aircraft had similar kinds of manufactured cracks or tears that had also been stop-drilled in the factory [A4].

-VI-3. Crack and Drill Hole in Reinforcing Plate at Starboard Rear Corner of Front ADF Aerial Window Comet G-ALYP

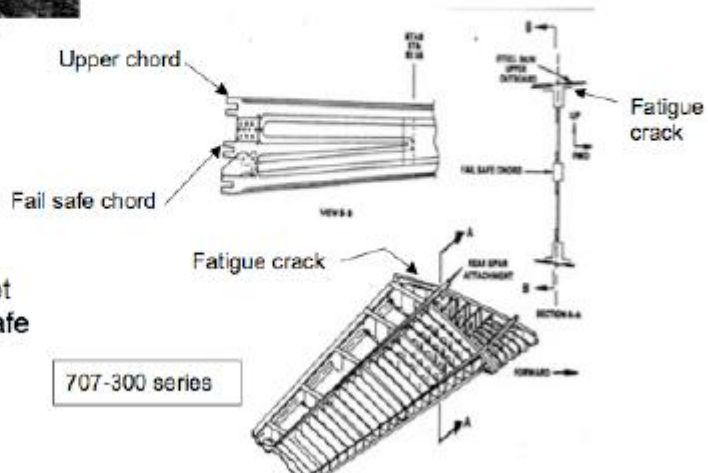
Upper spar chord fracture not
Found prior to failure of Fail safe
chord and loss of aircraft

Figure A18: Photo of Right Horizontal Stabilizer that Separated from B-707-321C Aircraft and Details of “Fail-Safe” Structure Associated with the Accident

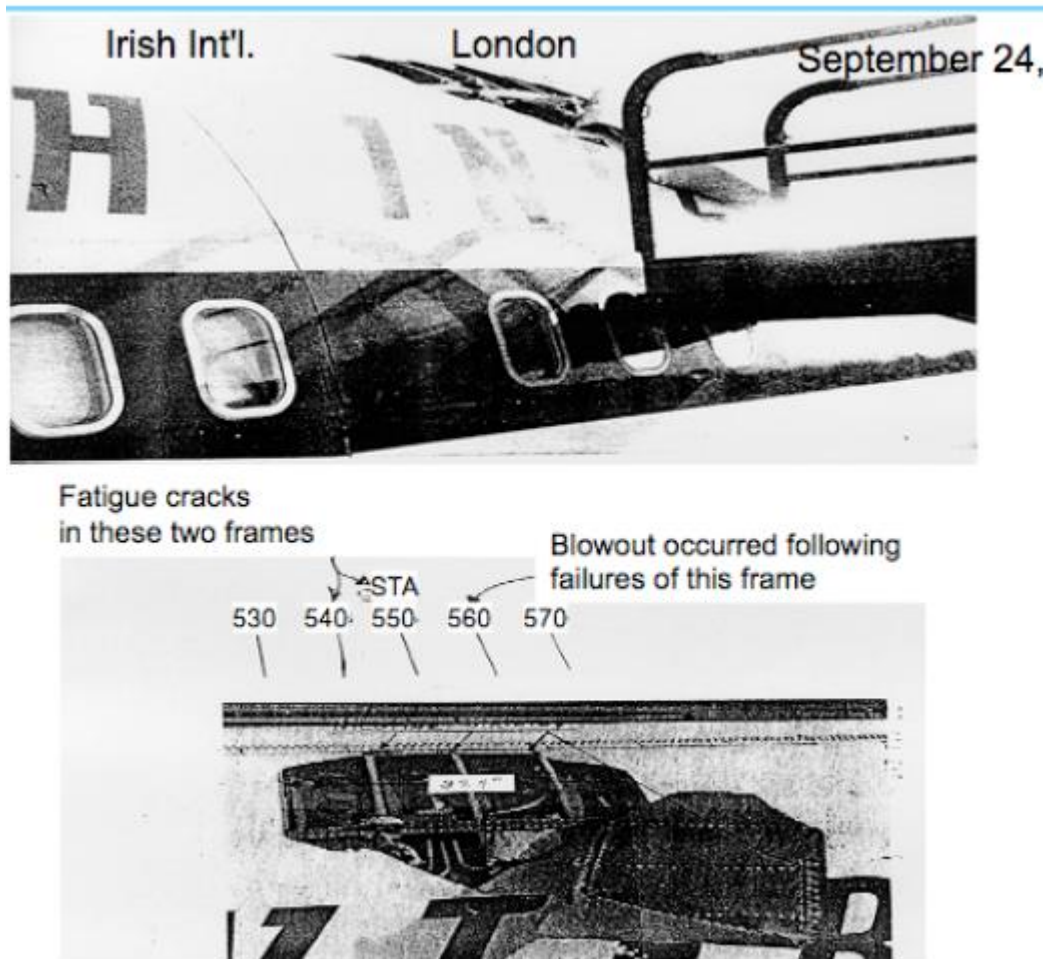
The location of the failure was in the main deck cargo door with frame failure and skin cracking along the upper hinge line. Note that the frame spacing in the cargo door is 10 inches rather than the normal 20 inch spacing throughout the rest of the fuselage. It is believed that the frame cracking occurred first followed by the skin cracking and the blowout. While the specific cause of the frame fatigue failures and skin cracking was not identified, it is expected that unanticipated high local frame stresses was the primary factor. It is not known whether or not there was any manufacturing or maintenance damage present. The main deck cargo door apparently was not included in the hydro fatigue test that was performed in the 1950s; thus, this critical area was not identified by the test. A photograph of the damage is shown in Figure A20.

Figure A20: Photo of Section of Boeing 707-300 Aircraft Lost Due to Fatigue Failure

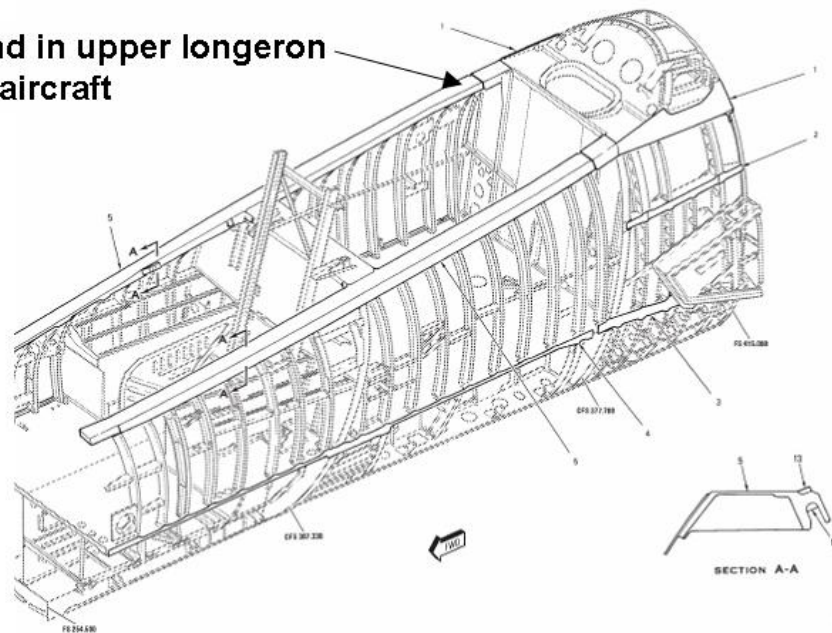
Figure 356. Main Structure Longerons (Sheet 1 of 4)

**Crack found in upper longeron
of mishap aircraft**

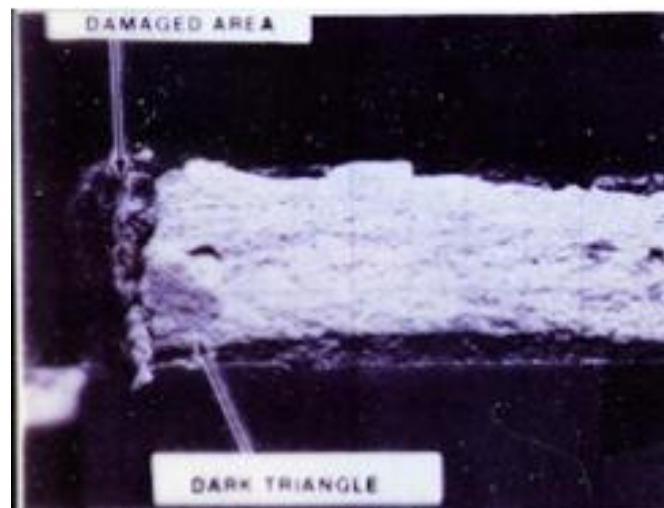
Figure B3: Tool Damage Led to Early Fatigue Cracking and Resulting Failure of the Monolithic Wing

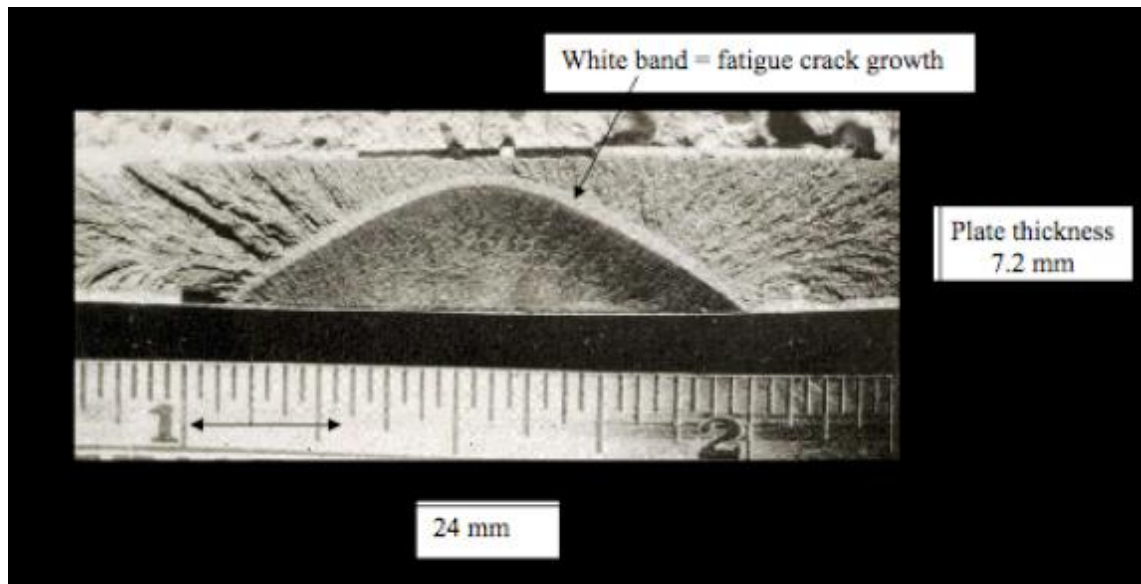
Figure B12: Photo Illustrating Forging Flaw and Subsequent Fatigue Crack that Caused the Failure of F-111 Aircraft after 105 Hours of Flight Time

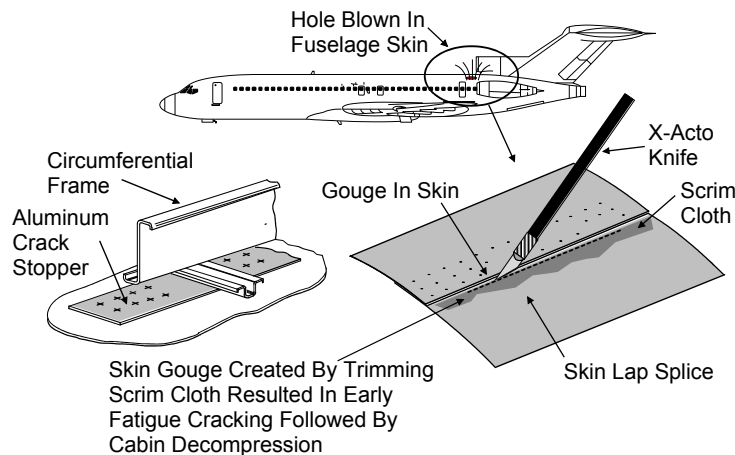
The second example concerns an Eastern Airlines 727 that suffered sudden cabin decompression caused by fatigue cracking induced by the X-Acto knife maintenance induced damage as shown in Figure C5. The rivets in the lap splice had been removed to clean out corrosion in the splice. Cold cure adhesive tape had been replaced and the excess tape trimmed off with an X-ACTO knife. The knife created a sharp gouge in the skin that became sites for the nucleation of fatigue cracks. Separate fatigue cracks linked together to form a long crack which eventually fast fractured and caused decompression. Fortunately, the fast fracture was successfully arrested by the aluminum crack stoppers located at the circumferential frames as shown in the sketch. The very large damage ‘crack arrest fail-safe’ capability designed into this fuselage saved this aircraft [C2, C3].

Figure C5: Maintenance Action that Led to Skin Failure by Fatigue

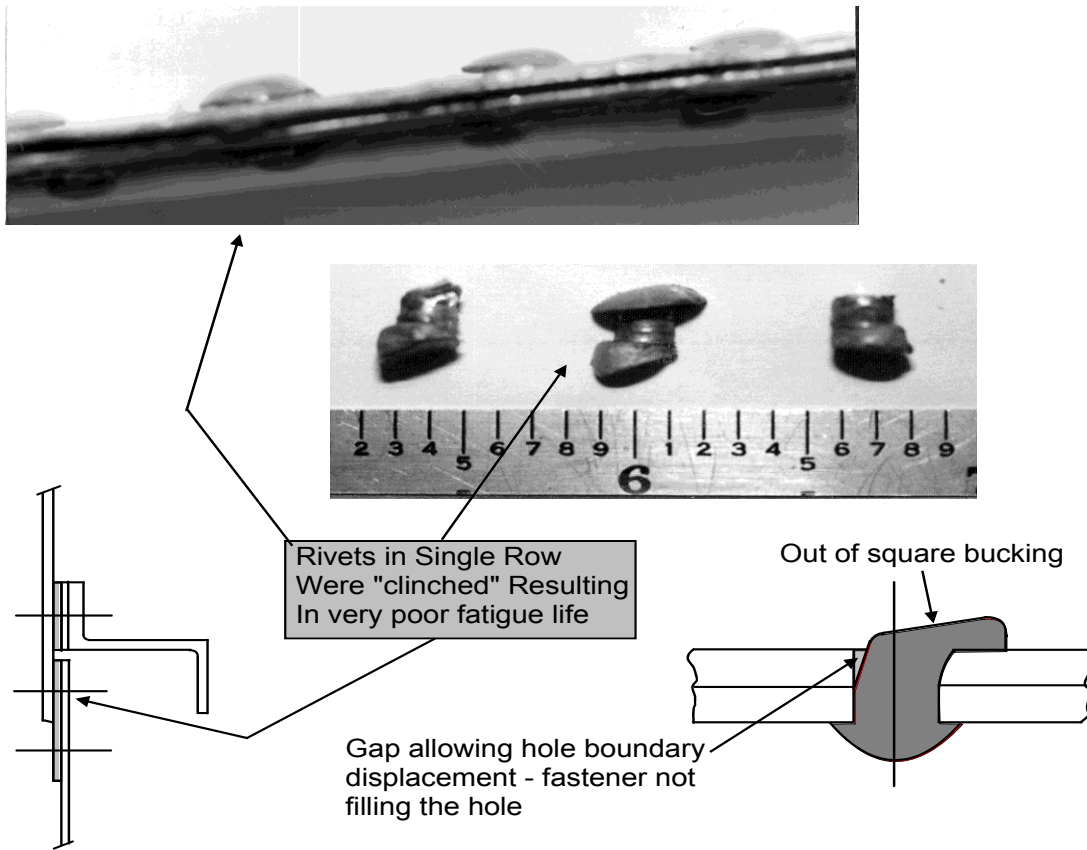
In addition to the manufacturing defect of the two-piece splice plate, the rivets in the single row were “clinched” as indicated in the photographs and sketches shown in Figure C12. Clinching is caused by misaligning the bucking bar to the rivet. Consequently the head is smeared to one side leaving a gap in the hole as shown in the figure. A clinched rivet does not properly fill the hole and will result in a much earlier crack initiation. Along with the high stresses caused by the single rivet row these repair defects contributed to the early development of the multi-site damage. In fact, it is quite possible that if these rivets had been properly bucked the airplane would have been retired before the accident took place.

Figure C12: Photos Illustrating Rivet Damage on 747SR Rear Pressure Bulkhead

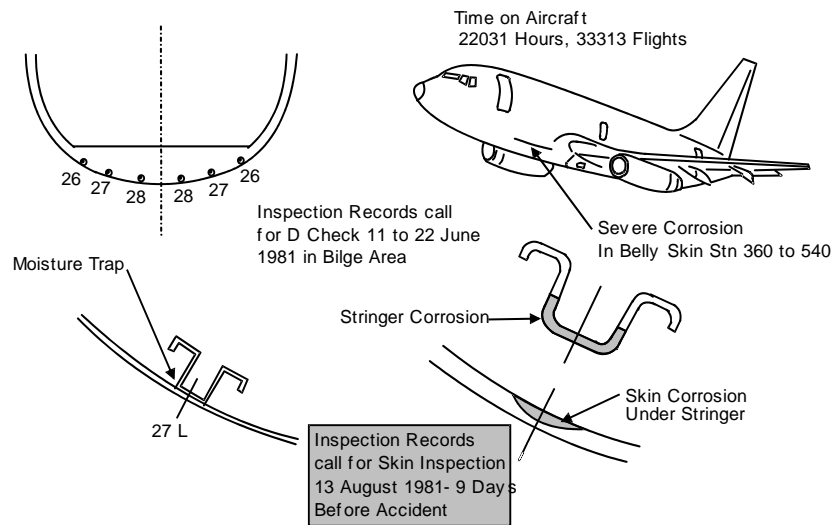
Figure D4: Sketches Illustrating the Locations and Causes of Corrosion on B737 Aircraft

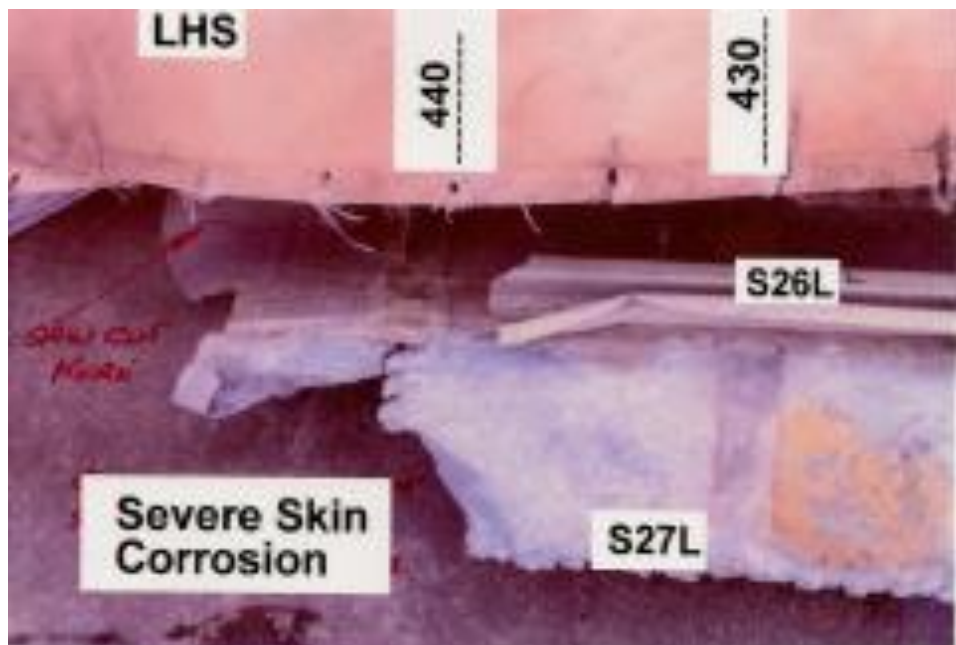
Figure D5: Photo of Skin Corrosion in Lower Lobe of B737 Aircraft

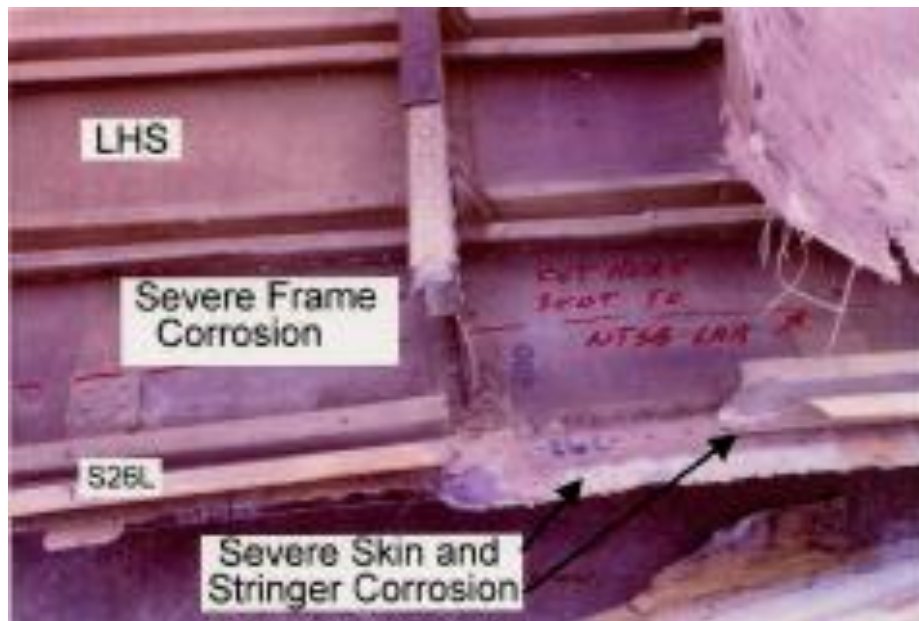
Figure D6: Photo Illustrating Loss of Frame and Stringer Due to Severe Corrosion

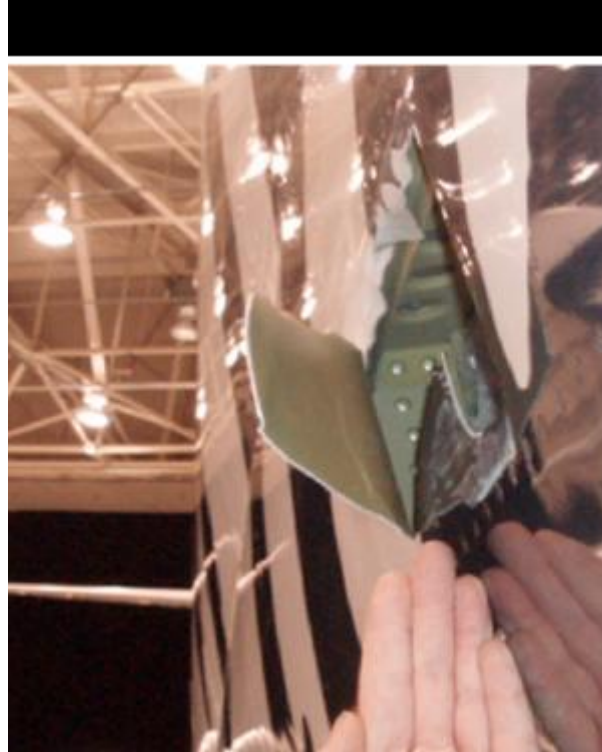
Figure E2: Photo of Skin Failure Following Ground Handling Damage

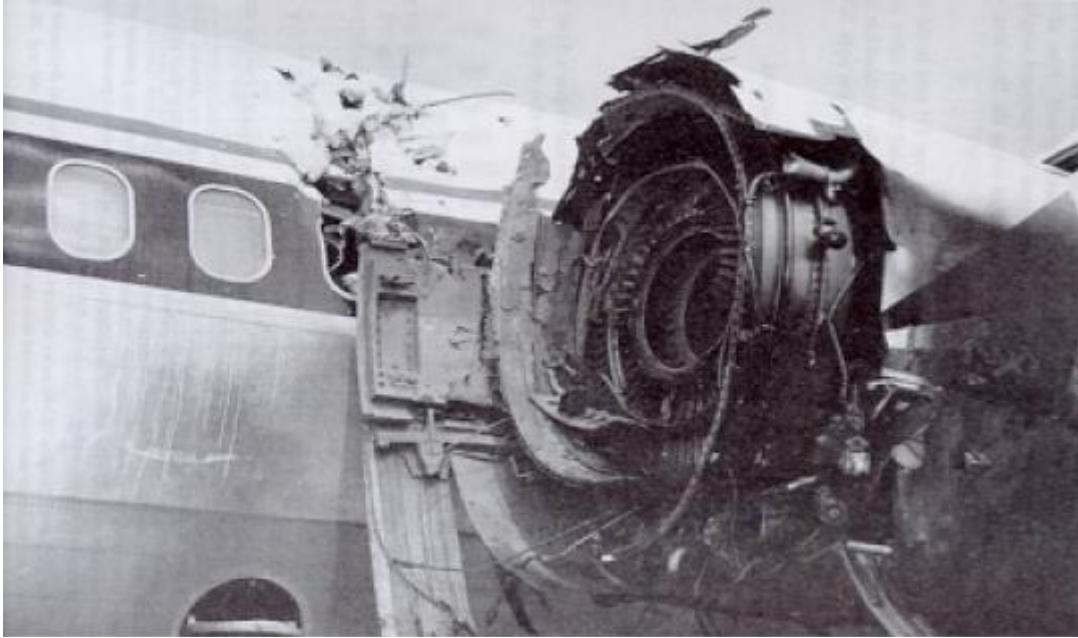
Figure F11. Photo of Engine and Fuselage Damage as a Result of Engine Failure

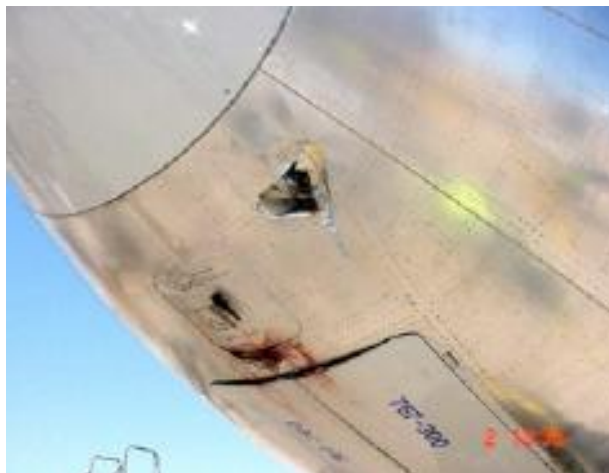
Figure G4: Photo of Bird Strike Damage to Underside of Fuselage of B767 Aircraft

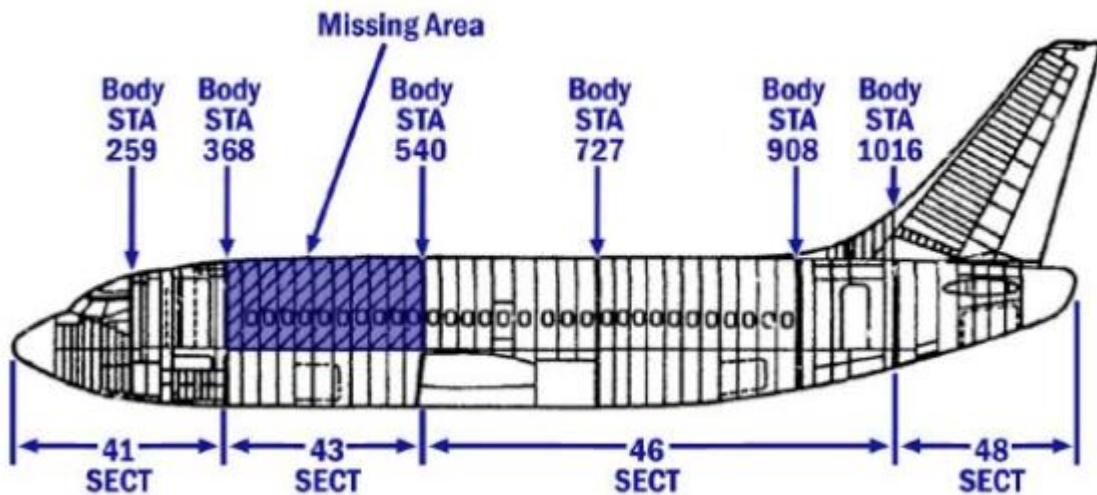
Figure J3: Sketch Illustrating Side View of Fuselage with Missing Area of Boeing 737 Aircraft

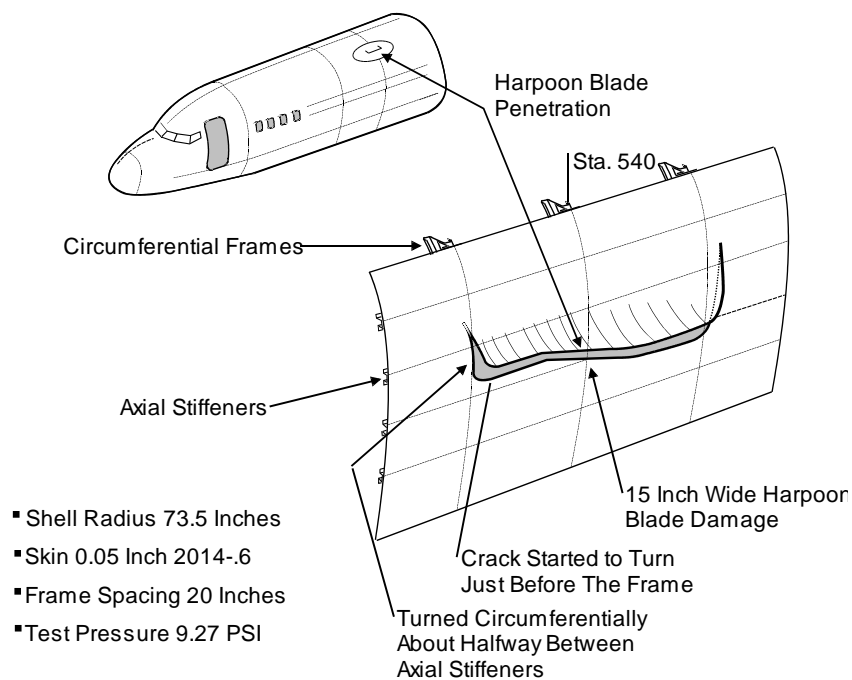
Figure K6: Details of DC-8 Arrested Fuselage Crack
